# **Characterizing GEO Titan IIIC Transtage Fragmentations using Ground-based and Telescopic Measurements**

## **Abstract**

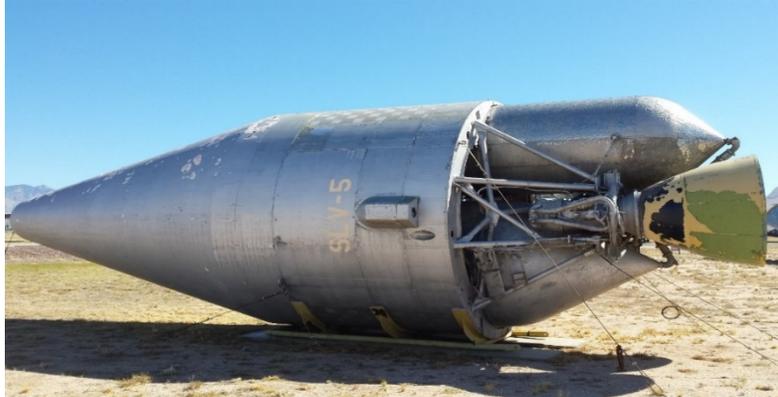
The authors found the Transtage test article resident at the U.S. Air Force's 309th Aerospace Maintenance and Regeneration Group (AMARG), better known as the "Boneyard," at Davis-Monthan Air Force Base in Tucson, Arizona. A June 2015 inspection by ODPO scientists Dr. Phillip Anz-Meador and Dr. Heather Cowardin determined that the Transtage object was probably an engine test article, one of the so-called "battleship" mockups used for design, integration, test, and validation, and not a flight ready vehicle. Digital images of the inspection are shown in Fig. 2 and Fig. 3.

Fig. 2. Titan III C Transtage test article stored at the “Boneyard.”

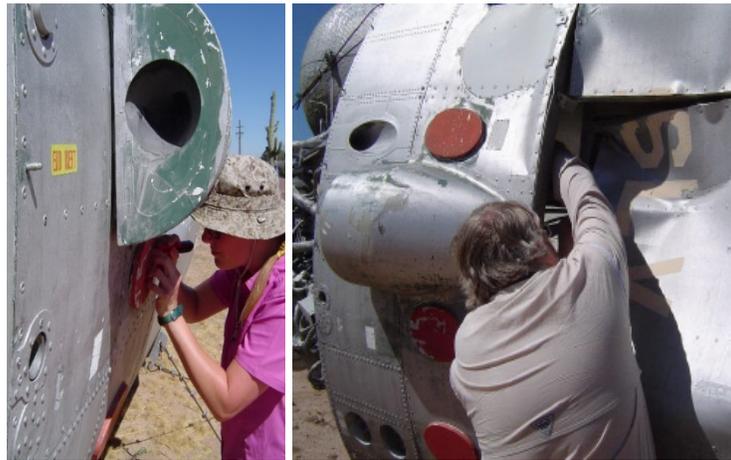
Fig. 3. Left, Dr. Cowardin acquires samples of external test article. Right, Dr. Anz-Meador acquires samples from interior of test article.

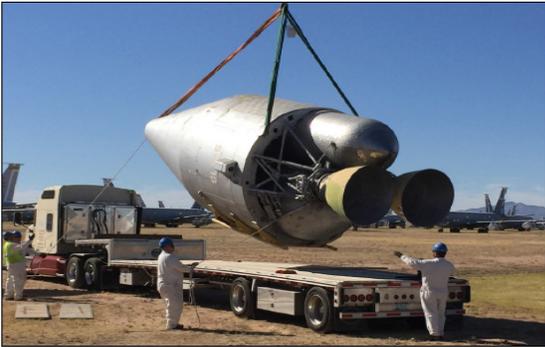
Fig. 4. The test article is lifted onto a tractor-trailer for transport to NASA JSC. (Image courtesy of Rob Raine, U.S. Air Force 309th Aerospace Maintenance and Regeneration Group).

The Titan Transtage test article arrived at NASA JSC on 26 May 2016. The following images (Fig. 4-7) show the journey of the test article from Arizona to Houston, Texas where it remains in storage. These figures help illustrate the size of the complex, asymmetric structure of this rocket body that was to be further analyzed at NASA JSC. Logistics aside, setting up the test article took coordination from various facilities, ensuring safety for all personnel, and removal of the nosecone to allow access to the interior structure to provide a more complete representative model for optical signature analysis. Once the test article was stored at NASA JSC Building 9 South (B9S), various inspections verified that it did not require any extra personal protective equipment to continue the investigation and analysis. The nose cone (or fairing) was removed to allow internal analysis of the test article, but after initial inspections found “contamination” from its long stay in the Boneyard’s desert environment, it had to be properly cleaned to remove animal/insect remains and other elements not associated with the test article. The starboard side engine bell (with respect to Fig. 2) was also removed to allow for closer inspection of the ablative materials within the thruster.

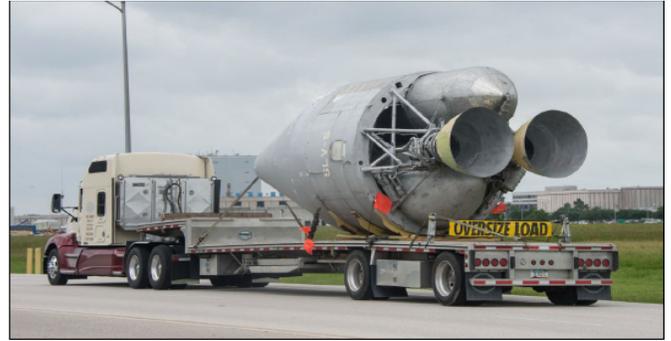
Fig. 5. The test article arrives at JSC after a road journey shared with curious drivers. The 18-wheeler was detained going through Houston by a curious sheriff who said, “You aren’t doing anything wrong. I just wanted to see what this thing was.” (Image credit: NASA/David DeHoyos).

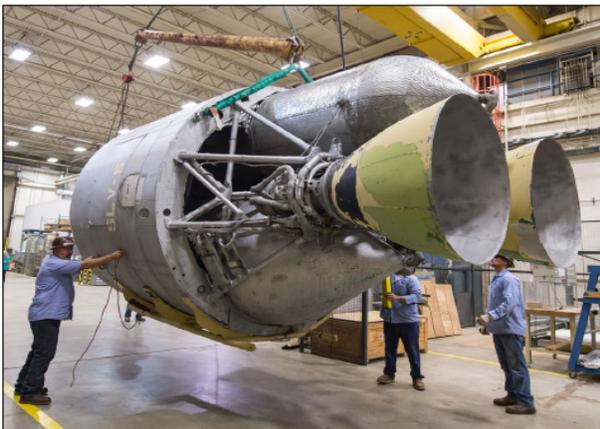
Fig.6. NASA JSC team members maneuver the test article into a holding cradle in theB9S high-bay. (Image credit: NASA/David DeHoyos).

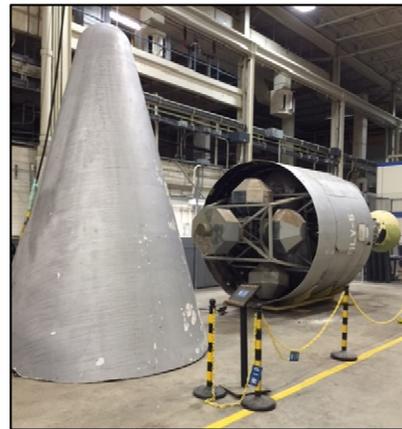
Fig. 7. Nosecone removal and staging after the test article’s arrival at NASA JSC. Note sample payload attachments that show how a Titan IIIC Transtage was used to put satellites in a GEO orbit.

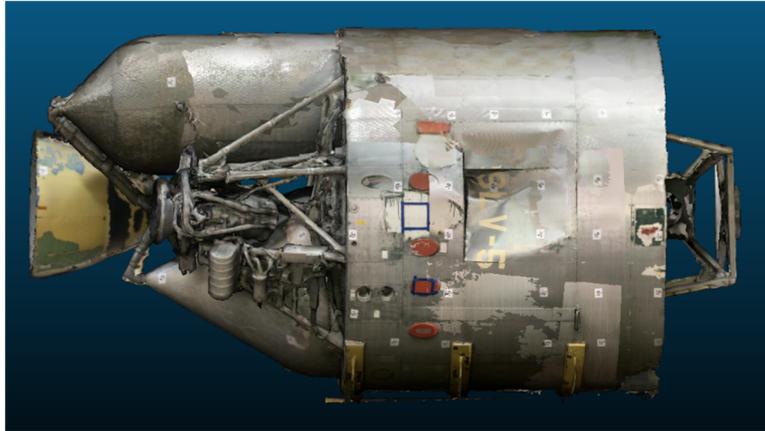
To better characterize the test article for future research, a scale model will be made in a size that will be used for OMC lightcurve signature analysis. A secondary goal is to generate a 3-D point cloud from a scan of the entire test article and then use software codes to test theoretical explosion/fragmentation events based on hydrocode analysis of known targets. To meet these requirements, the Image Science and Analysis Group (ISAG) at NASA JSC provided support via a handheld LIDAR system mounted on an iPad Air 2 [11, 12]. Because the test article was much larger than the LIDAR’s intended use, the team collected approximately 60 scans and images, which they ordered topologically to ensure completeness in the scanning collection. The instrumentation created a 3-D point cloud with a digital overlay as shown in Fig. 20 and Fig. 21.

Fig. 20. LIDAR digital overlay of the test article.

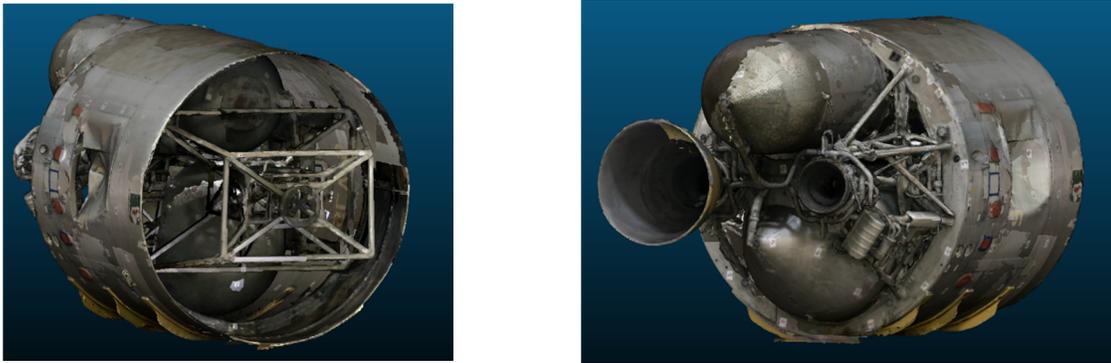
Fig. 21. LIDAR digital overlay, payload end (left), thruster end (right).

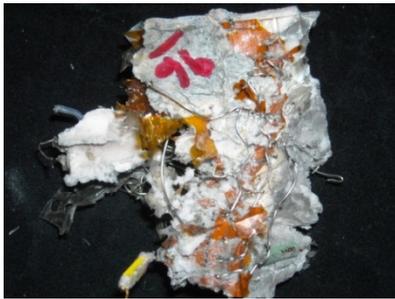
Fig.22. Composite fragment from an impact experiment based on a 1960s era Transit satellite. The color-color plot matched the closest with the observed SSN 3432 Titan Transtage fragment.
