# Characterization of Hypervelocity Impact Debris from the DebrisSat Tests

**Paul M. Adams, Patti M. Sheaffer, Zachary Lingley and Gouri Radhakrishnan**

*The Aerospace Corporation, 2310 East El Segundo Blvd., El Segundo, CA 90245*

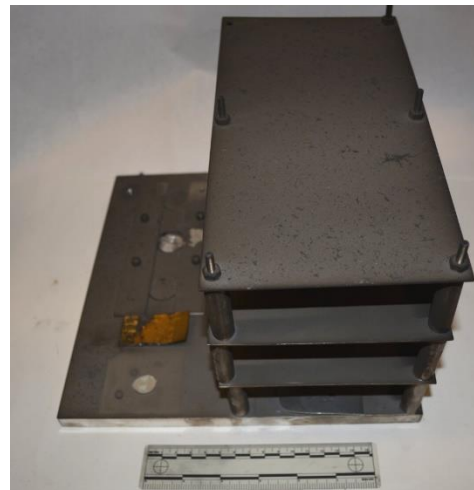
Fig. 2. Pretest witness plate assembly consisting of two sets of three 1" diameter fused quartz windows held down with stainless steel strips. One set of samples was fully exposed and the second set was protected under three steel Whipple plates (Left). Witness plate assembly post-test (Right).

A witness plate assembly was provided by Aerospace in order to collect debris for laboratory analysis, to identify materials produced by the impact and measure the albedo of debris (Fig. 2L). The witness plate assembly was located on the side of the chamber between the 3<sup>rd</sup> and 4<sup>th</sup> bumper shields (Fig. 3L). In the test the first four bumper shields were perforated by the projectile, the fifth was partially perforated and the frame was dislocated from the frame (Fig. 3R). The sixth shield (Kevlar) was deformed but was still intact [19]. We were not able to examine the remains of the target and debris in the chamber after the test. The witness plate assembly was shipped to Aerospace for analysis.

Exposed surfaces of the witness plate assembly were covered with a matte gray coating and fine debris (Fig. 2R). Larger deposits tended to be concentrated toward the down range side of the plate. The witness coupons located under the Whipple plates were relatively clean and uncoated compared to those which were uncovered (Fig. 4). This implies a highly directional nature to the impact deposits. Some of the material consists of loose micron- to nano-sized solidified molten droplets of an (Fe-Cr-Ni)-rich phase and an oxide/silicate phase (Fig 5L). The surface can be seen to be covered with small (< 1  $\mu\text{m}$ ) solidified molten droplets of the (Fe-Cr-Ni)-rich phase and larger droplets (to 100  $\mu\text{m}$ ) of the oxide/silicate (Fig. 5R). A loose flake of this material was potted in epoxy and sectioned and polished (Fig. 6). The material collected on the witness plate formed a thin continuous layer about 10-20  $\mu\text{m}$  thick, solidified from molten droplets of the two phases that have a complex intermixed flow structure. The material consists of a crystalline (Fe-Cr-Ni)-rich phase and amorphous oxide/silicate phases [20].

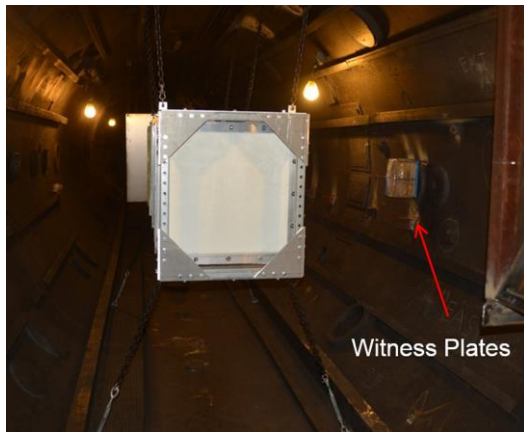
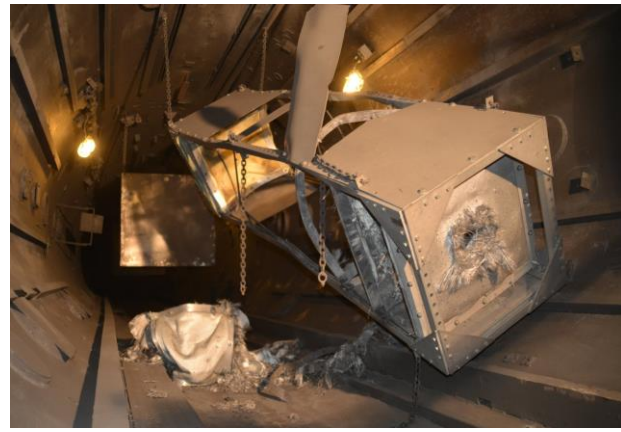
Fig. 3. Pre Preshot target hanging in AEDC vacuum chamber looking down range. Witness plate assembly was mounted on the side of the chamber facing the target (Left). Target post-test looking down range. The fifth bumper shield is lying on the floor of the chamber (Right). Images by AEDC.

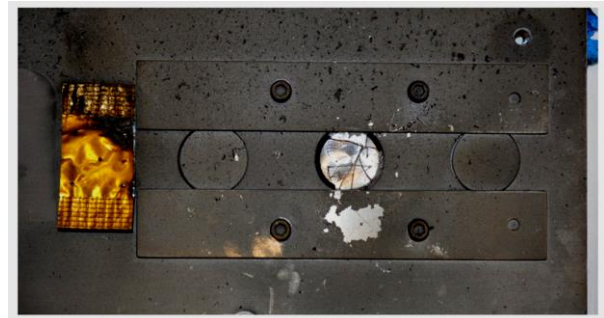
Fig. 4. Post-test witness samples. Coupons protected under Whipple plates; three 1” fused silica windows and Kapton multilayer insulation (MLI) (Left). Exposed coupons; center window has been broken and coating has flaked off lower hold-down strip and MLI (Right).

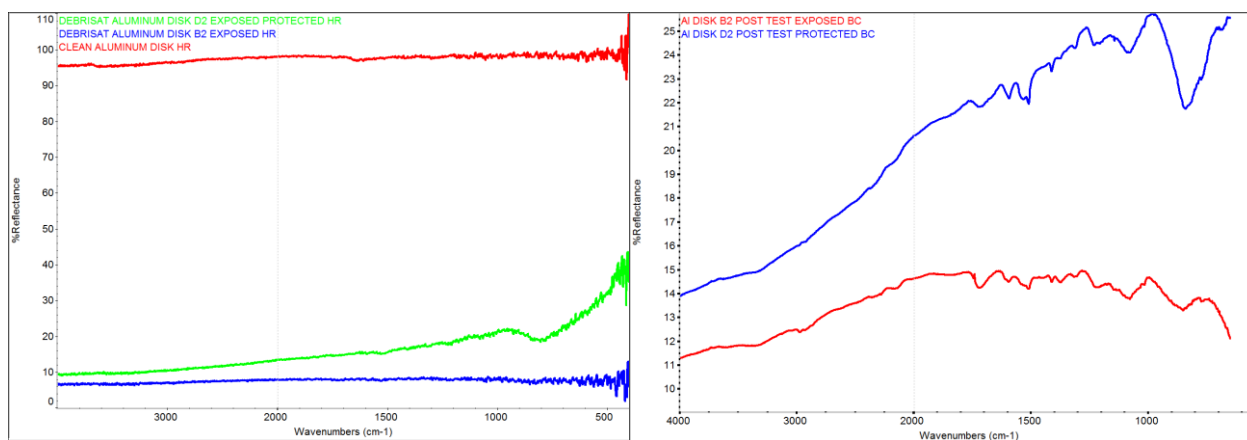
Fig. 21. FTIR hemispherical reflectance spectra of witness plate deposits (Left). Qualitative biconical FTIR reflectance spectra of witness plate showing soft catch (1800-1000  $\text{cm}^{-1}$ ) and possible aluminum oxide (800  $\text{cm}^{-1}$ ) absorption bands (Right).

The witness plates show a significant decrease in FTIR hemispherical reflectance from 95% to 6% (Fig. 21). Soft catch contamination was seen in the FTIR reflectance spectra of DebrisSat fragments, SEM stubs and witness plate. As a result, it was not possible to get a clean spectrum of the debris generated by the hypervelocity impact. An additional “oxide” band, which may be from a form of aluminum oxide, was seen on some samples (Fig. 21R).
