Mirror Recoating of Large Primary Optic

Abstract

Over the course of 2021, the Air Force Research Laboratory and the site's contractor, Boeing, recoated the primary mirror of the Department of Defense's largest optical telescope. The Advanced Electro-Optical System (AEOS) has a 3.67m primary mirror as part of its Cassegrain design. In order to maintain excellence in Space Domain Awareness (SDA) data collection, the primary mirror is periodically stripped of its reflective coating and recoated with a new bare aluminum coating. The purpose of this paper is to provide insight into the details and challenges of the large mirror recoat process required to maintain sensitive SDA telescope instrumentation in top working condition. This paper will cover the end-to-end process to include assembly of mechanical lifting equipment, critical lifts of the large optical assemblies, dis-assembly of the mirror cell, stripping/cleaning the optic, application of the new coating, and reassembly of the telescope. Also included are the challenges of maintaining clean room conditions throughout the process, ensuring little or no residue remains on the mirror post stripping/cleaning, achieving positionin

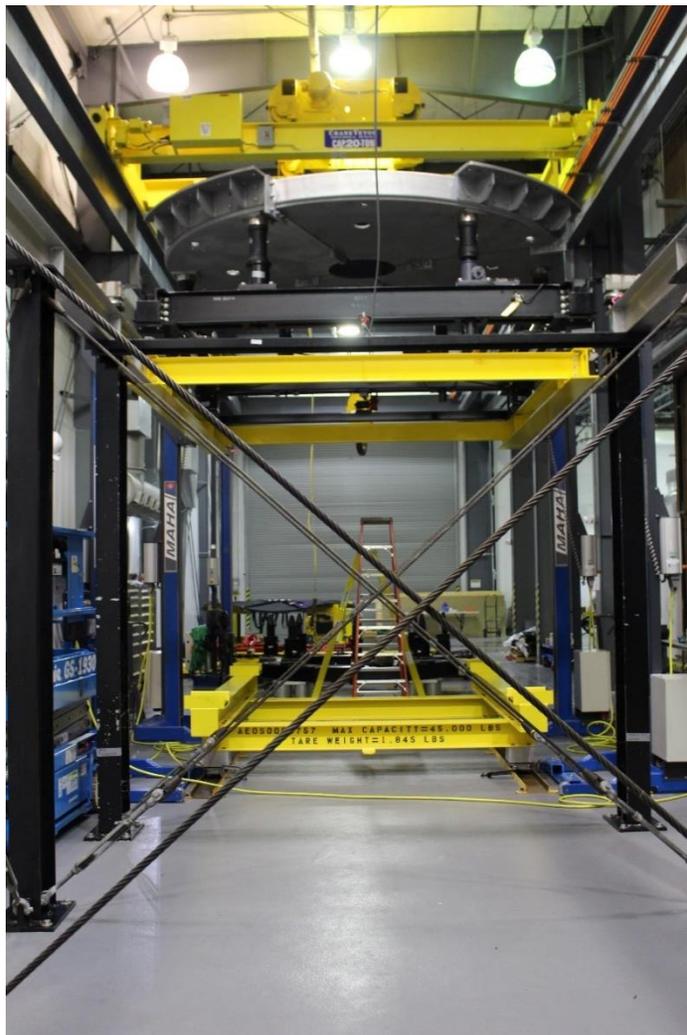
Figure 1- Simulation in the MCF

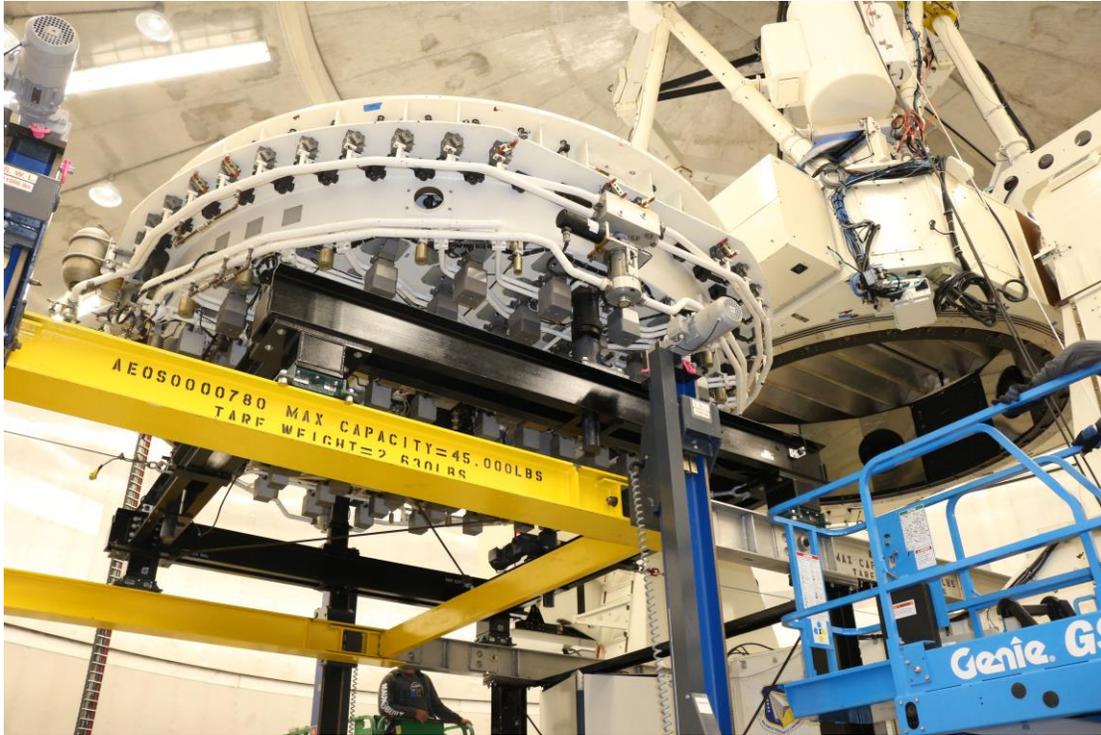
Figure 2 - Mirror Cell Removal from Telescope

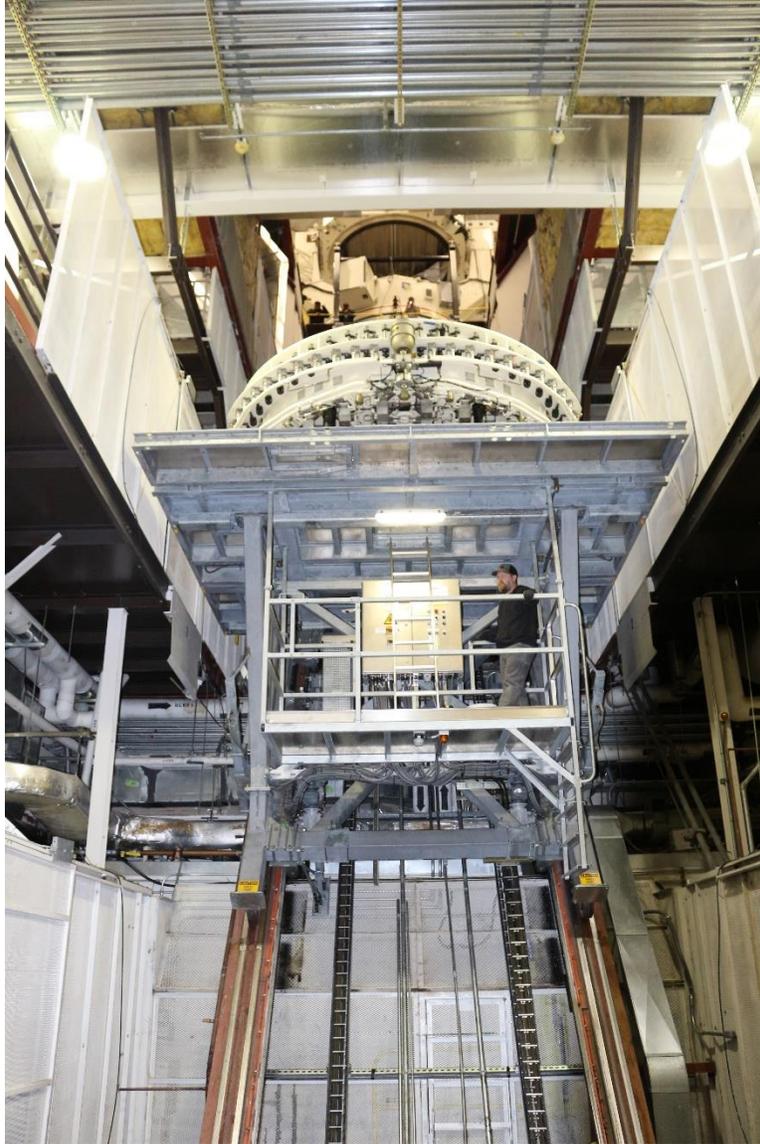
Figure 3- Transportation of mirror cell from 4th floor to 1st floor

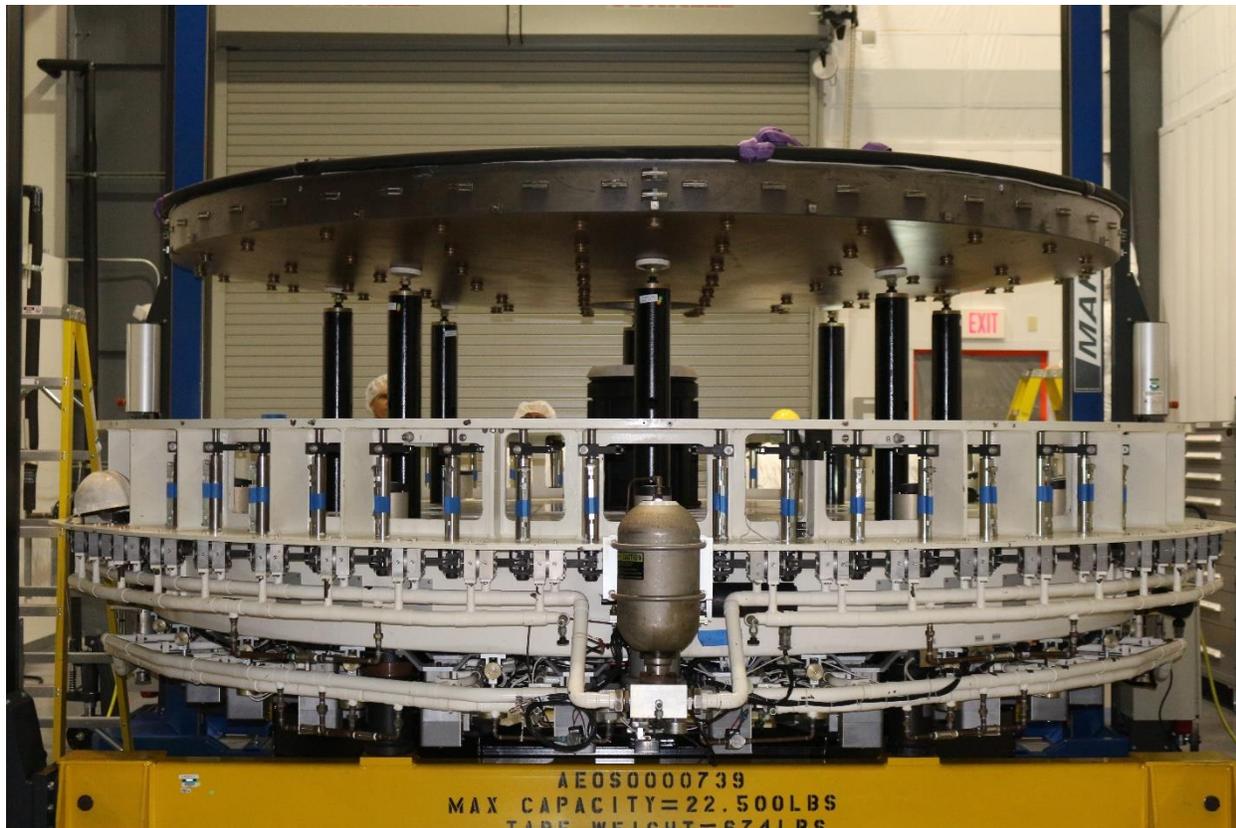
Figure 4- Separation of substrate from mirror cell

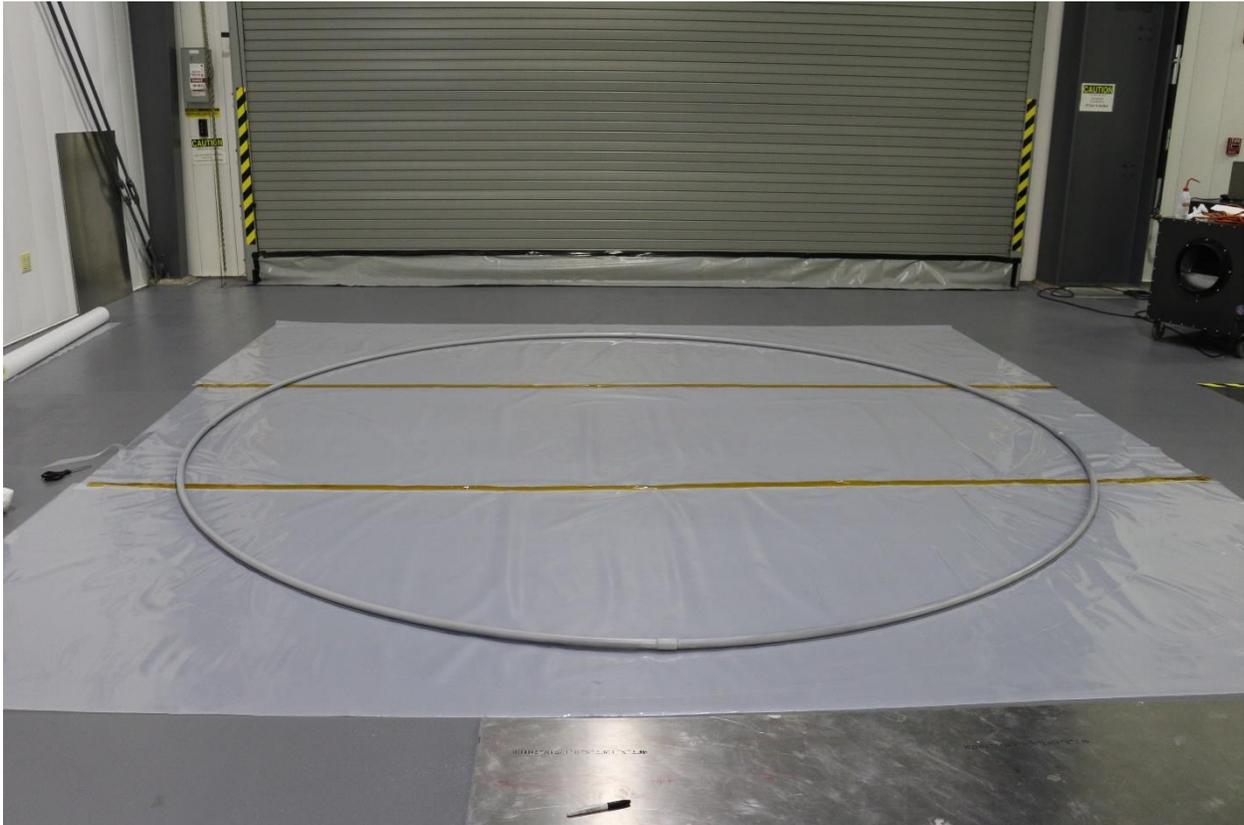
Figure 5- Drumhead Cover Assembly

The frame of the cover is a torus of PVC pipe with a major diameter that is a few inches larger than the substrate diameter. This hoop is a frame onto which the cleanroom plastic is stretched. All of the components, as well as the area for assembly, should be thoroughly cleaned. If the substrate is larger than the width of the roll of folded virgin cleanroom plastic, several sections will need to be attached together with Kapton tape. The sheets should not be unfolded, but instead cut at the seams and taped together; this will minimize contamination and allow a large enough section. It cannot be stressed enough to maintain the cleanliness of the two inside surfaces of the cleanroom plastic; an understanding of this needs to be clear with all personnel involved. After the double plastic sheet is completed, the pvc ring is placed on top of both sheets. The top sheet is then cut to a size roughly twelve inches larger radially than that of the pvc hoop. Cutting triangular sections out of the upper plastic from the larger diameter plastic sheet terminating an inch or so from the outer diameter of the hoop will facilitate pulling individual sections up and over the hoop to be taped onto the top of the plastic.

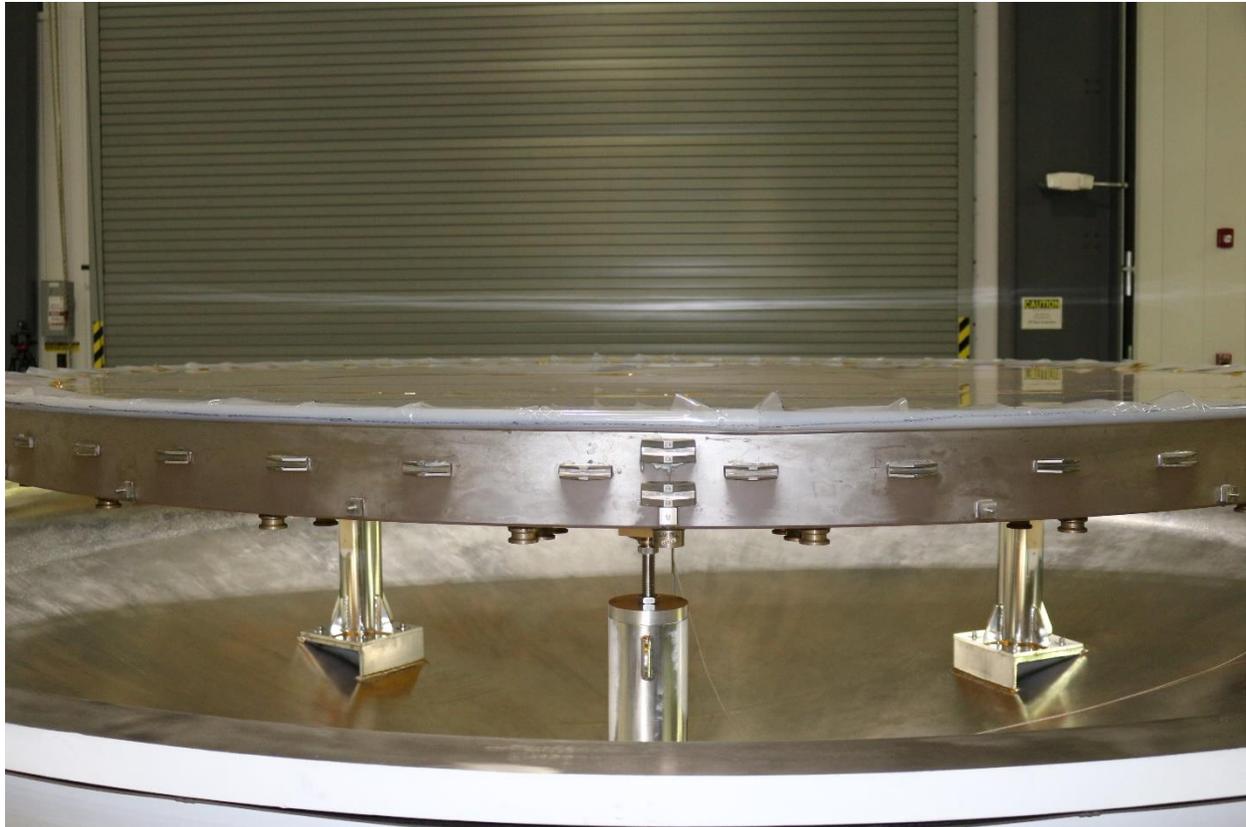
Figure 6- Drumhead cover over substrate

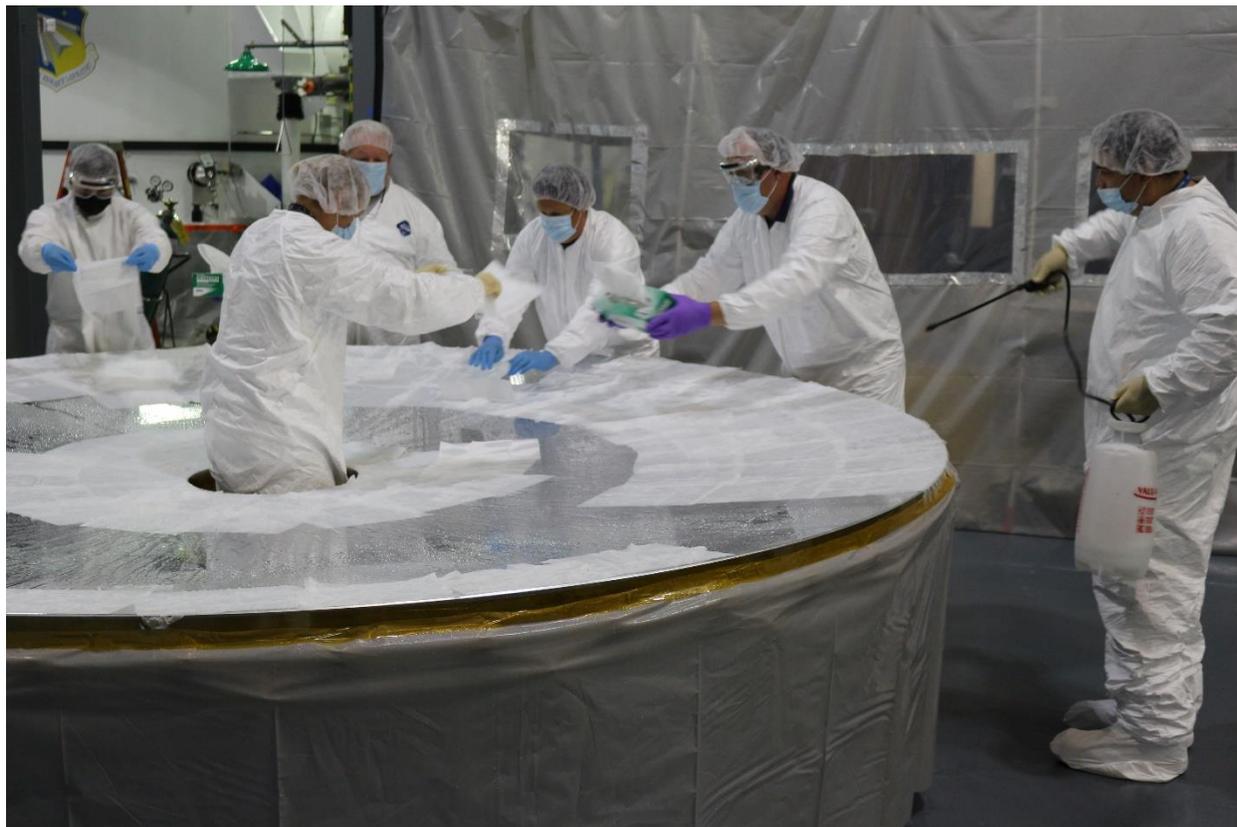
Figure 7- Application of wet wipes

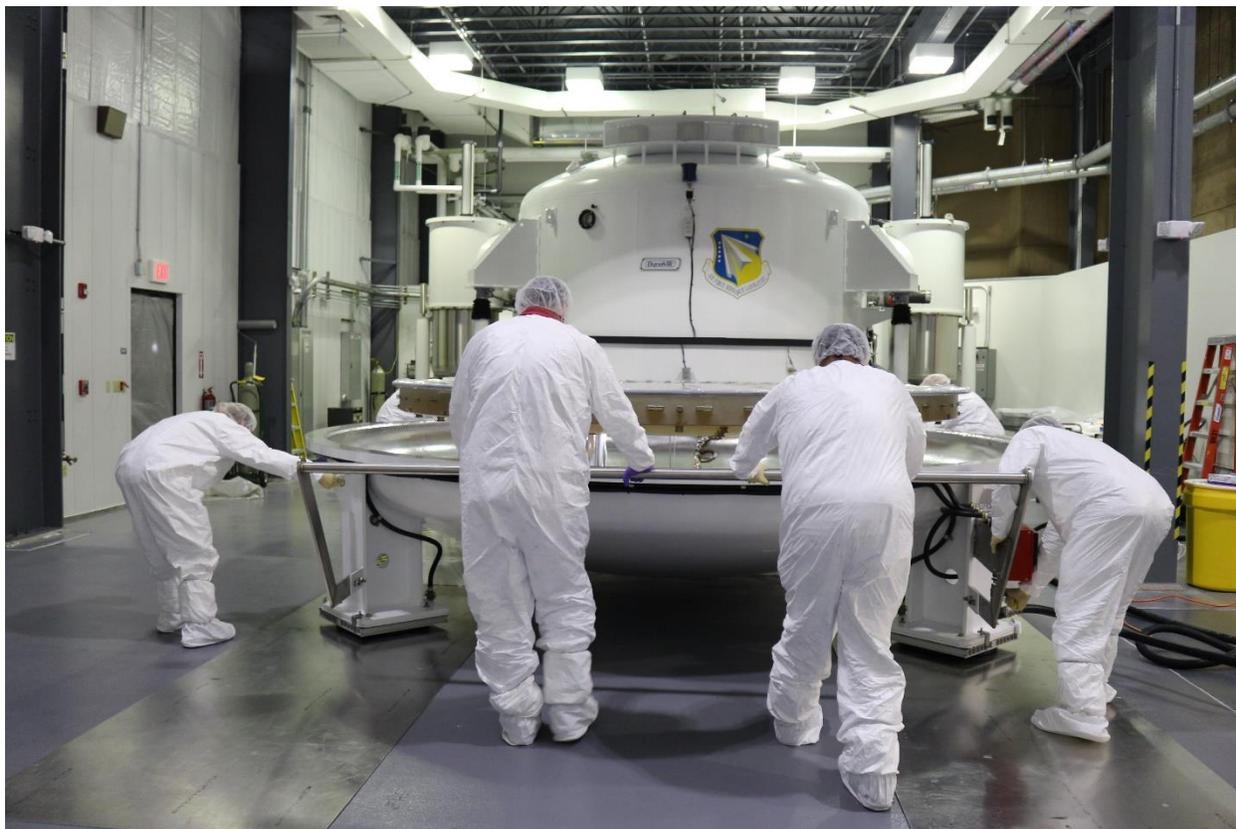
Figure 8- Substrate in route to coating chamber

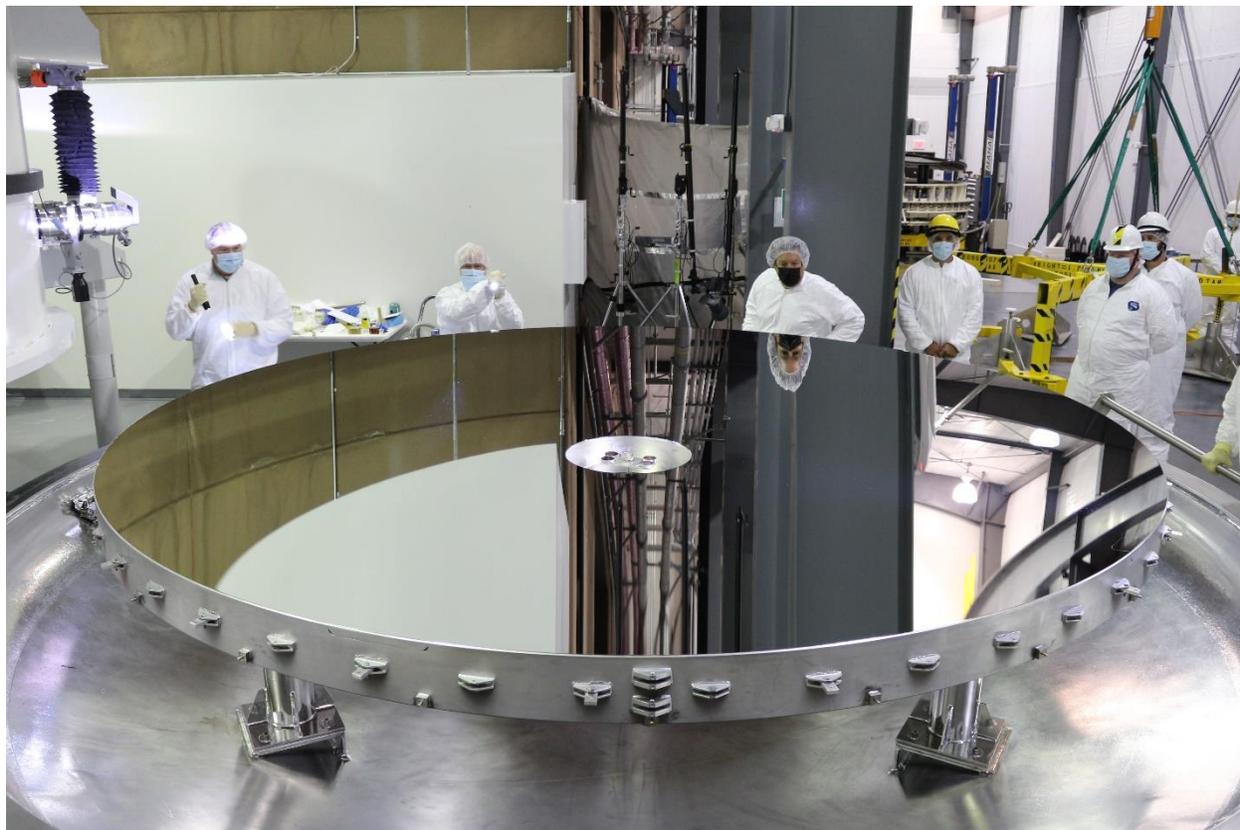
Figure 9- 2021 Mirror Leaving the Coating Chamber

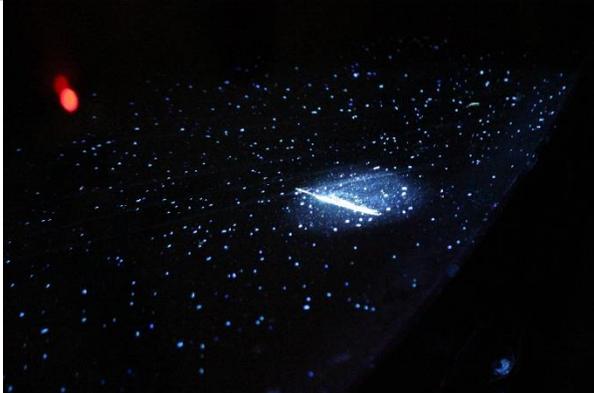
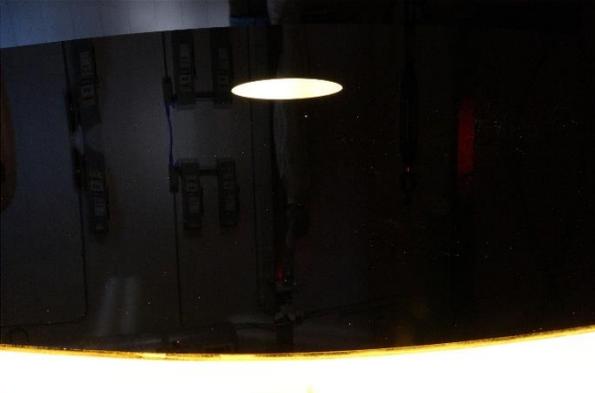
Table 1 - Mirror Pinhole Photos

- **Pinholing**
 - While shining a bright light from behind the mirror, pinholes were observed in the coating. The number of pinholes larger than 0.5mm were tallied over select areas on the mirror surface. The same method was used to tally witness sample pinholes except with the use of a microscope

Previous Recoat pinholing	2021 Recoat pinholing

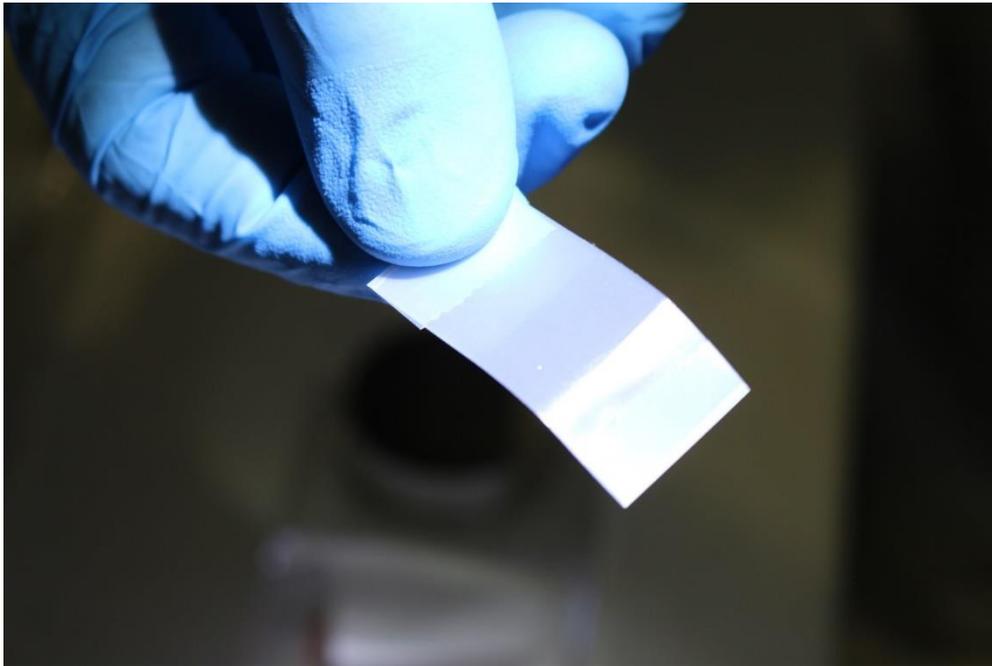
One of the most worrisome tests to perform is that of the tape test as there is a potential for damage to the fresh coating. This test consists of putting various adhesive level scotch tape onto the mirror surface and pulling at specific rates to verify that the aluminum coating is well adhered to the substrate. Figure 10 shows one of the tape tests results with no aluminum being pulled off of the mirror.

Figure 10 - Mirror Inspection Tape Test Sample
